ADDENDUM NO. 3 TO PROJECT NO. 44345

**CONSTRUCTION WORK
PROVIDE REMEDIATION OF VILLAGE FIRING RANGE
FRANKLIN CORRECTIONAL FACILITY
62 BARE HILL ROAD
MALONE, NY**

May 10, 2013

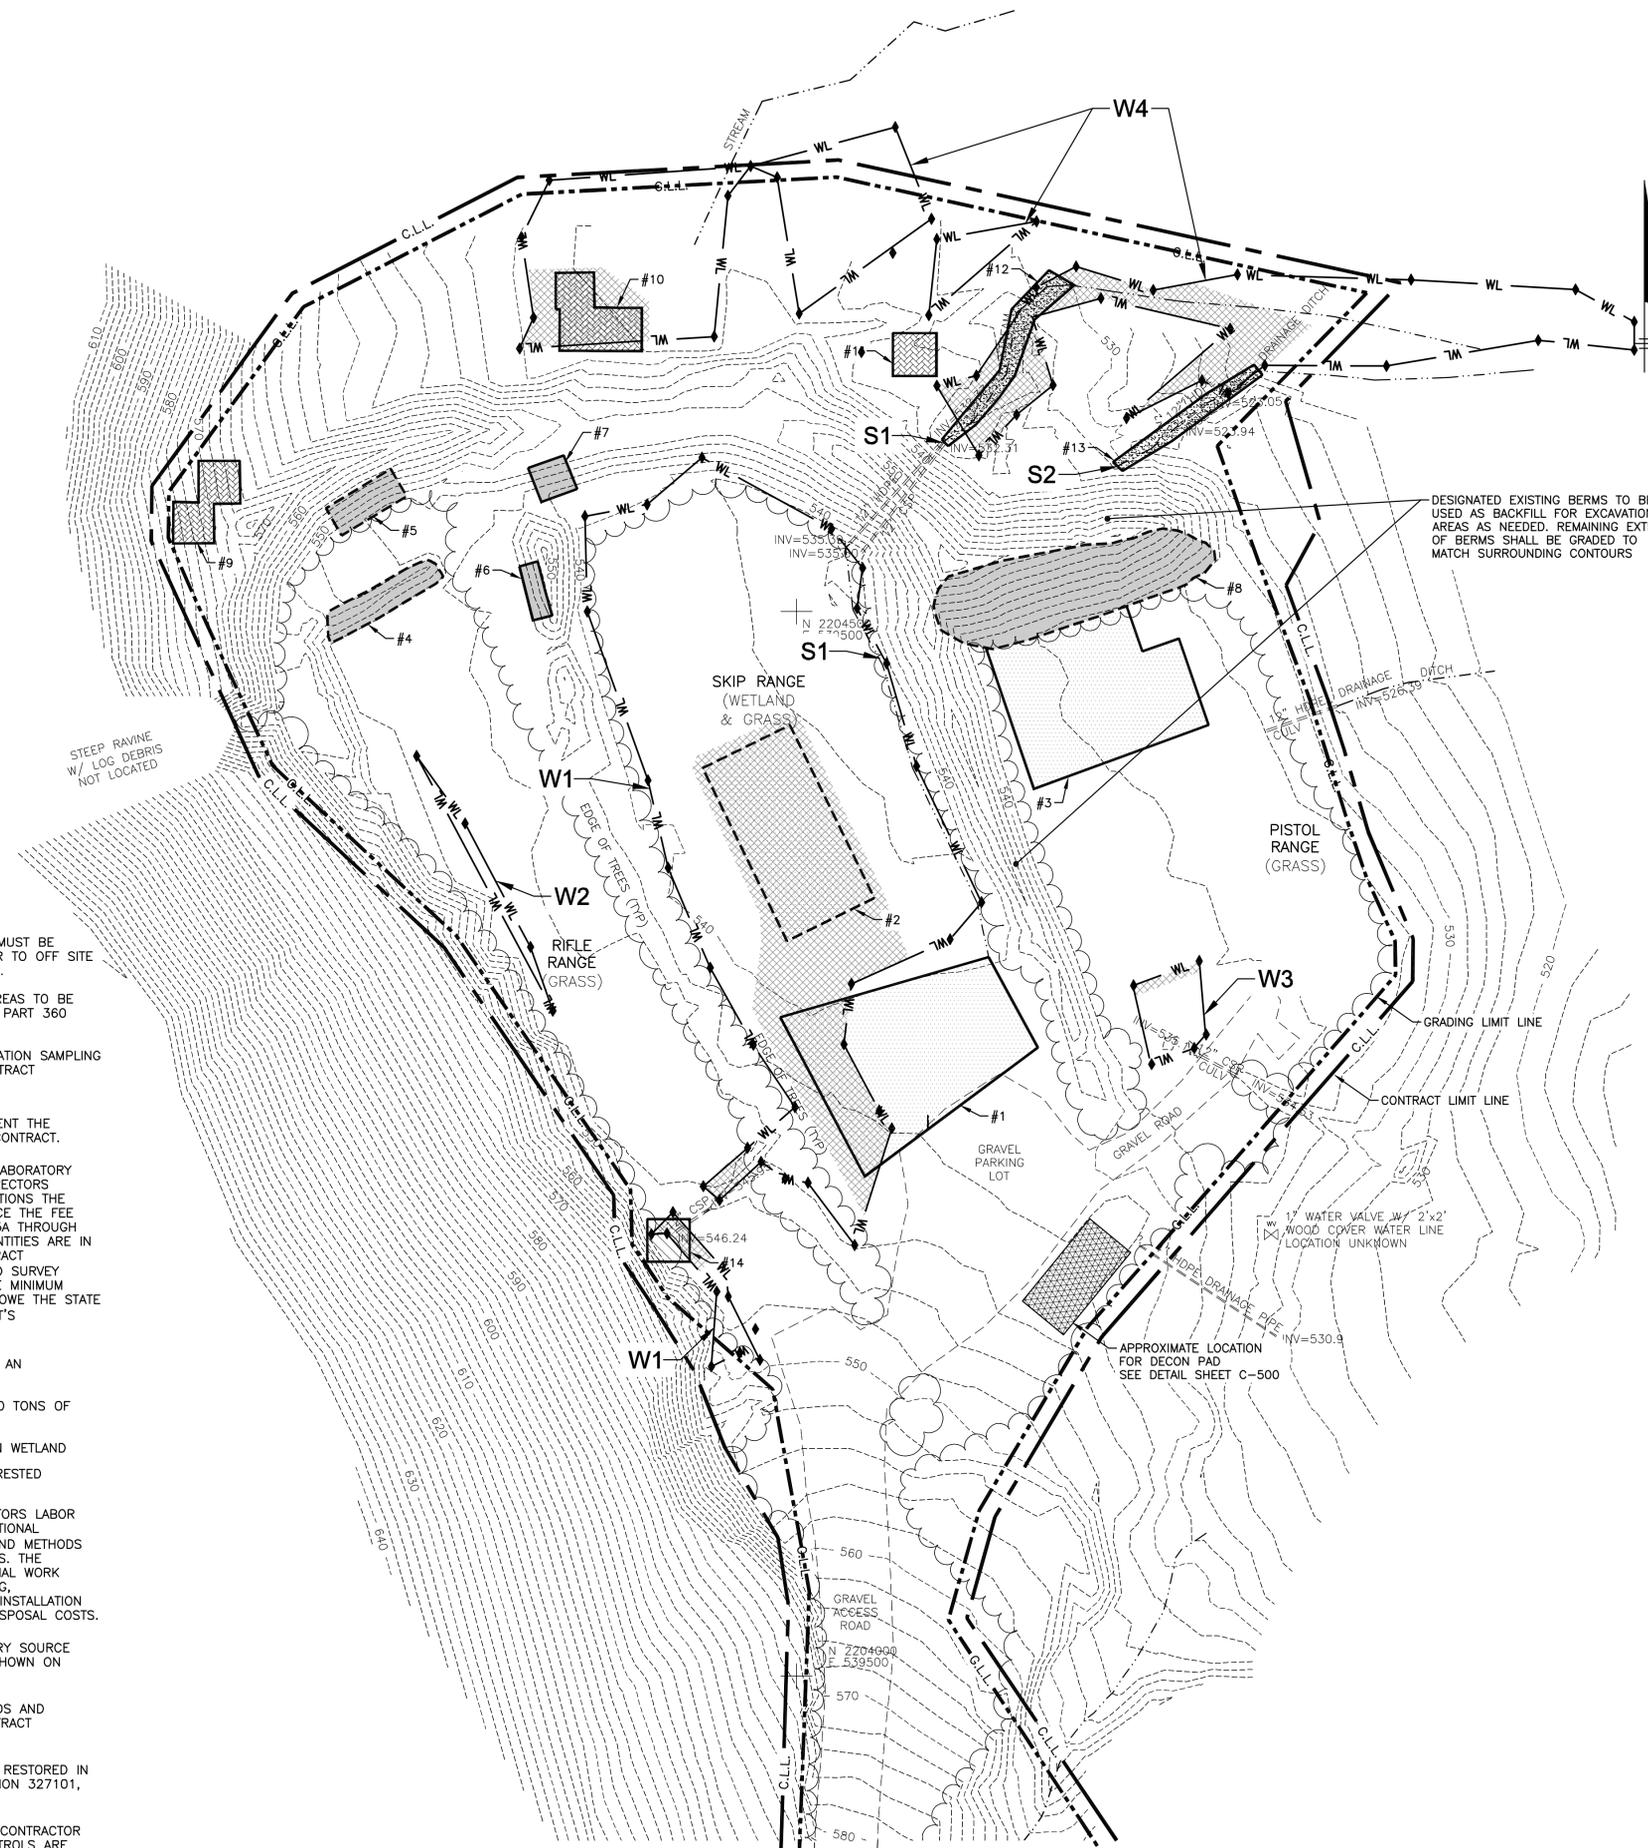
DRAWING NUMBER: C-104

SHEET TITLE: MATERIAL EXCAVATION PLAN

APPROXIMATE EXCAVATION DEPTHS

EXCAVATION NO.	DEPTH (FT.)
1	2
2	1
3	1
4	REMOVE TO MATCH SURFACE GRADE
5	6
6	2
7	2
8	REMOVE TO MATCH SURFACE GRADE
9	1
10	1
11	1
12	1
13	1
14	1

1. SOIL DEPICTED IN HAZARDOUS SOIL EXCAVATION AREAS MUST BE TREATED AND STABILIZED IN SITU BY CONTRACTOR PRIOR TO OFF SITE DISPOSAL AT A 6 NYCRR PART 360 PERMITTED LANDFILL.

2. SOIL DEPICTED IN NON-HAZARDOUS SOIL EXCAVATION AREAS TO BE DISPOSED OF OFF SITE BY CONTRACTOR AT A 6 NYCRR PART 360 PERMITTED LANDFILL.
3. CONTRACTOR TO PERFORM HAZARDOUS WASTE DETERMINATION SAMPLING & WASTE CHARACTERIZATION AS DESCRIBED IN THE CONTRACT DOCUMENTS (SPECIFICATION 028003 & 028335).

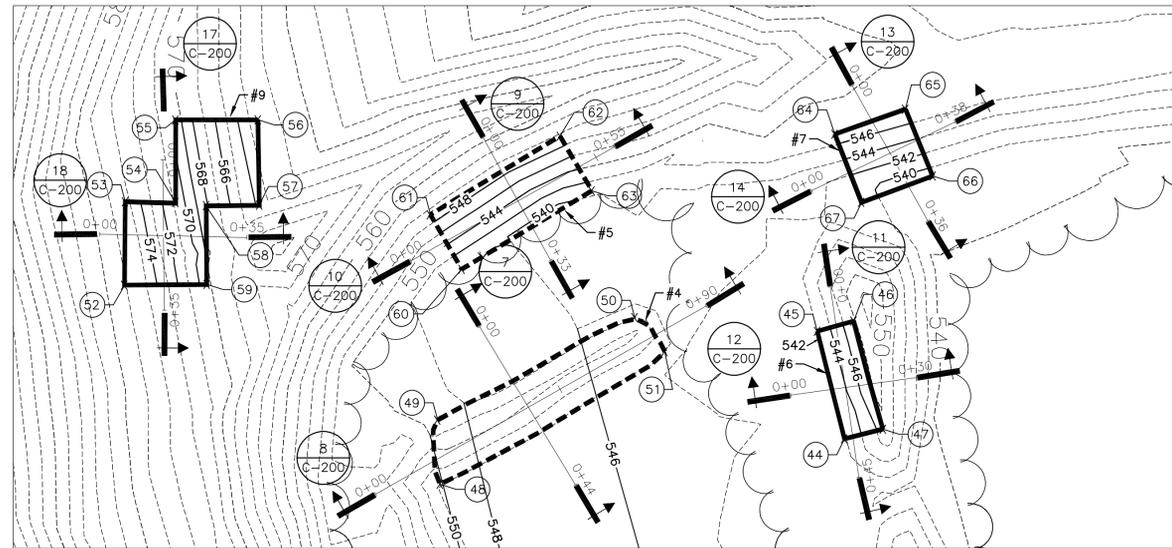
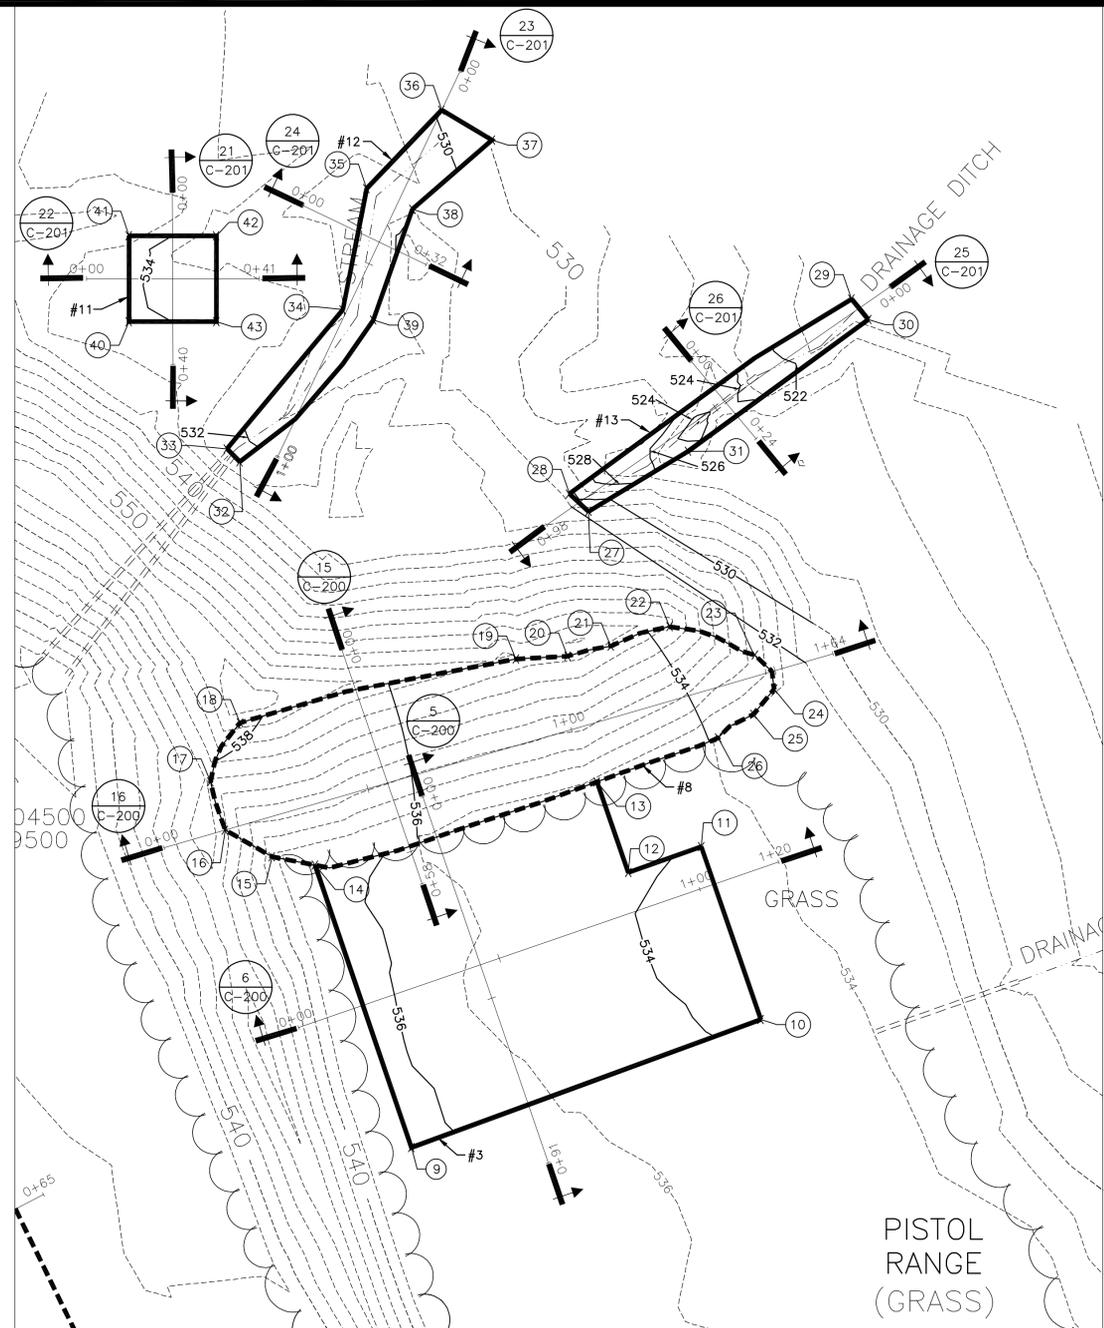
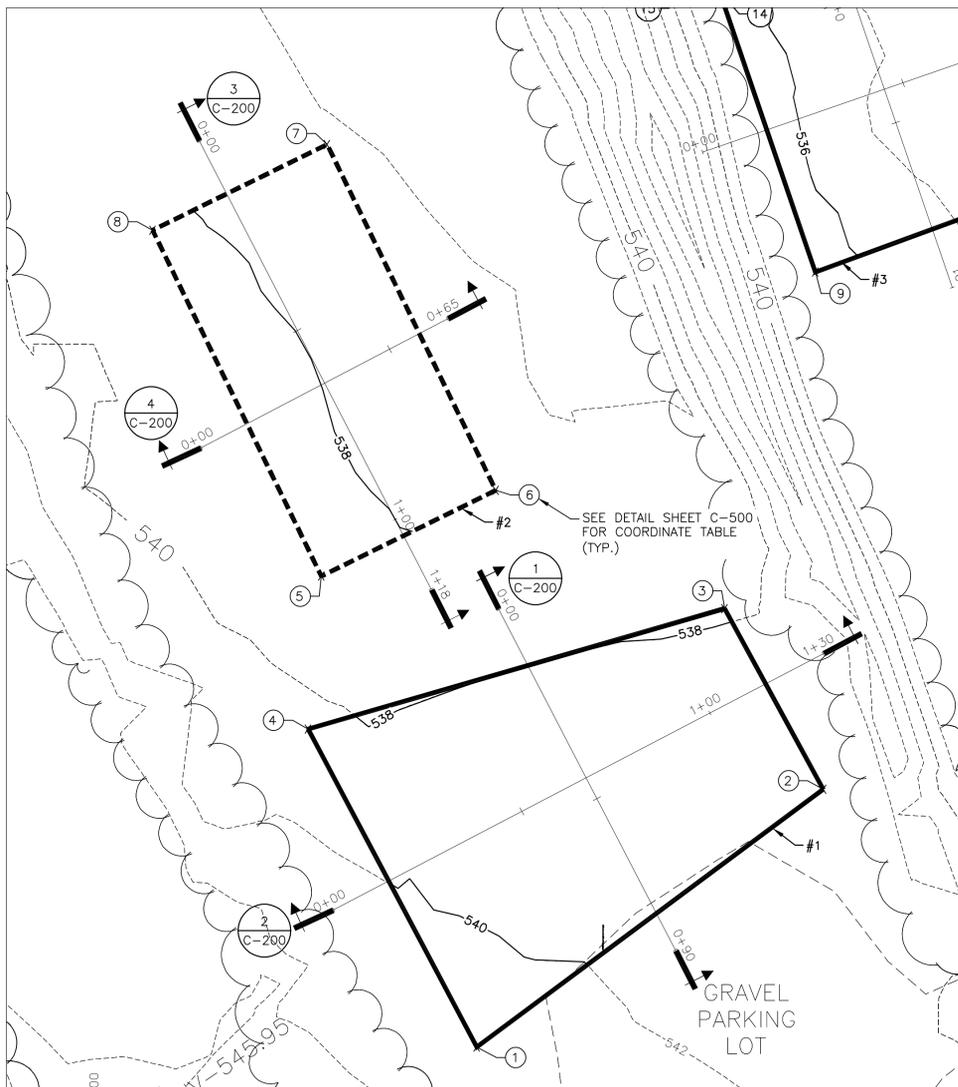
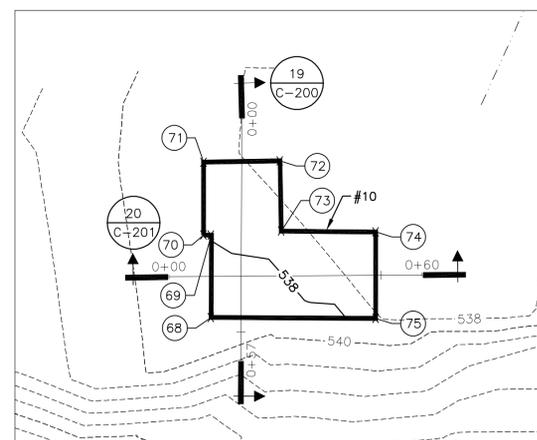
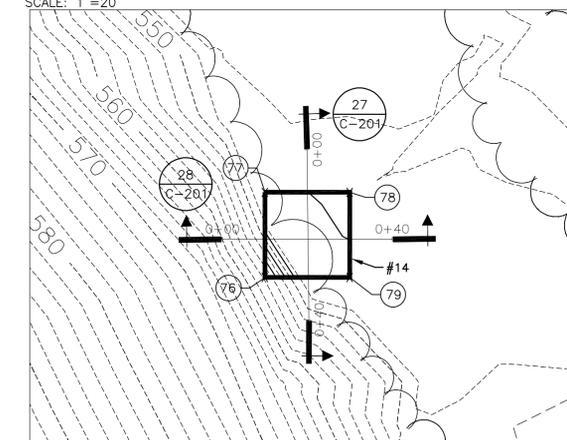
DRAWING NUMBER: C-105

EXCAVATION DETAILS & CROSS SECTION LEGENDS

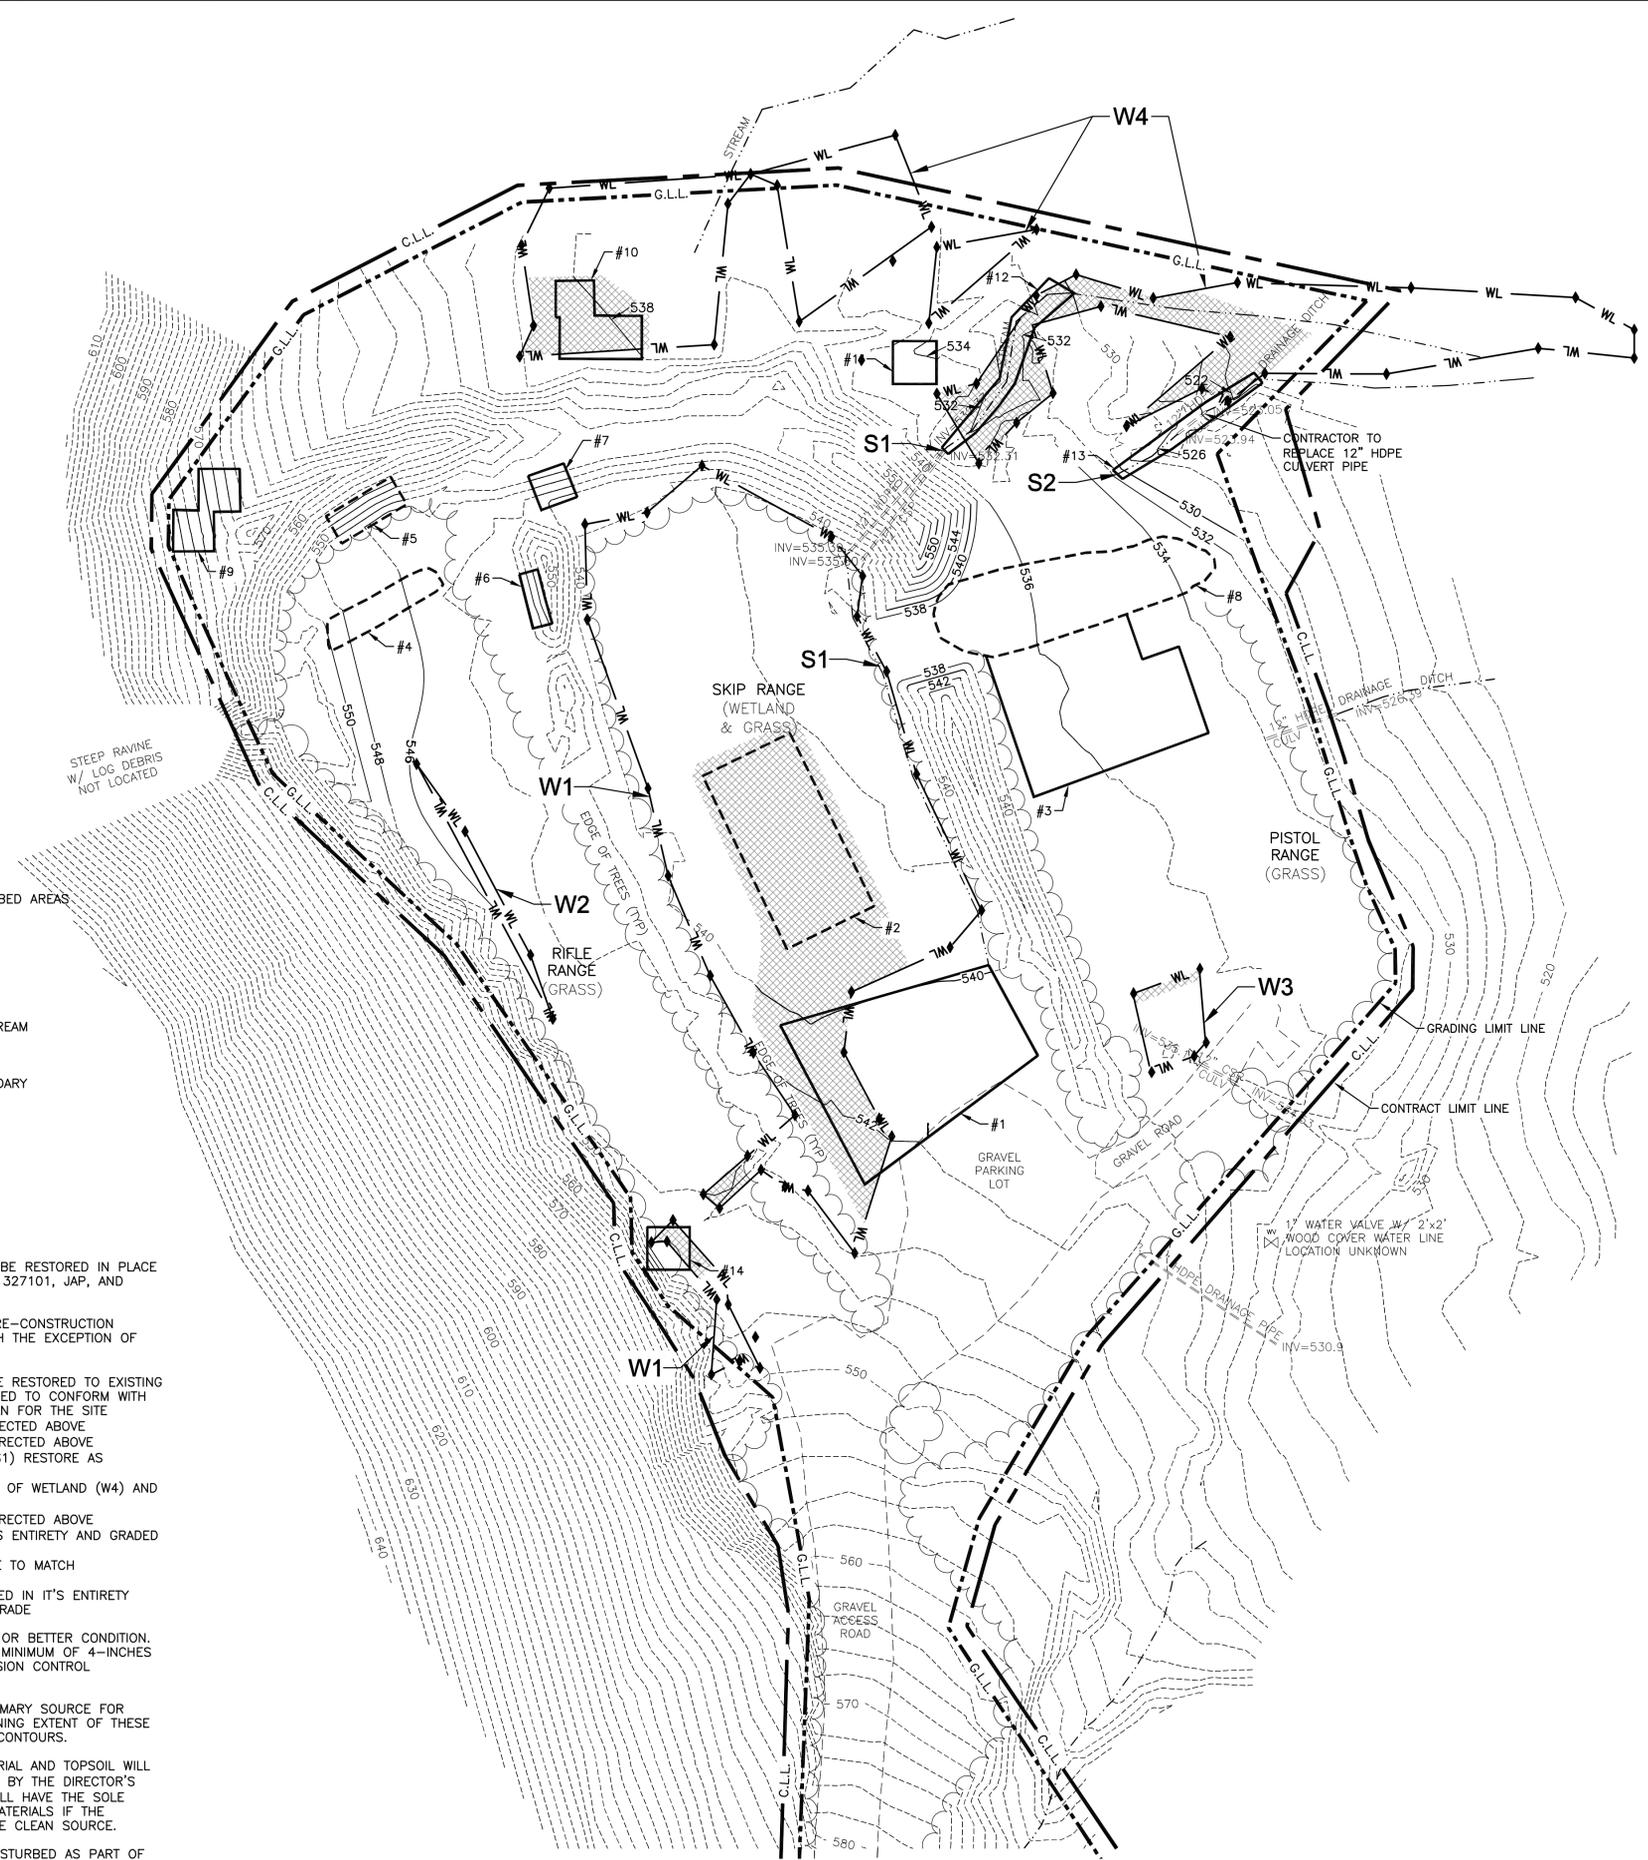
DRAWING NUMBER: C-106

- EXCAVATION #8 - FACE OF BERM WILL BE REMOVED IN ITS ENTIRETY AND GRADED TO MATCH SURROUNDING SURFACE GRADE
- EXCAVATED AREAS SHALL BE RESTORED TO ORIGINAL OR BETTER CONDITION. EXCAVATED AND DISTURBED AREAS SHALL RECEIVE A MINIMUM OF 4-INCHES TOPSOIL, SEED AND MULCH FOR SEDIMENT AND EROSION CONTROL MEASURES.

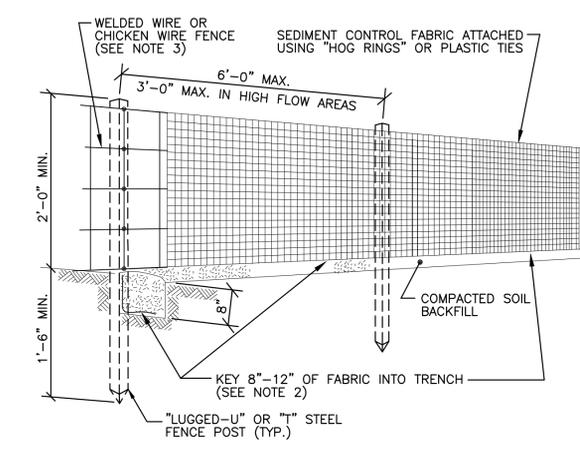
SILT FENCE DETAIL
NOT TO SCALE

- DETAIL NOTES:**
- PRE-MANUFACTURED SILT FENCE SUCH AS ENVIROFENCE BY MIRAFI OR APPROVED EQUAL. IN SUCH CASE, ELIMINATE WELDED WIRE/CHICKEN WIRE FENCE.
 - KEY TOWARD UPSLOPE SIDE.
 - WELDED WIRE SHALL BE 14.5 GAUGE WITH 6-INCH MESH.

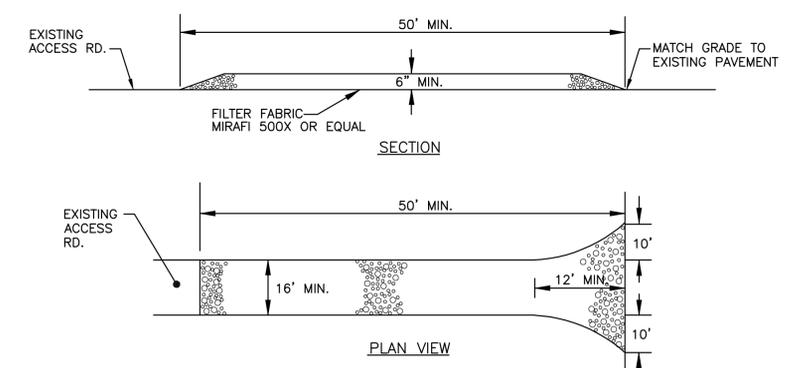
- STABILIZED CONSTRUCTION ENTRANCE SPECIFICATIONS**
- STONE SIZE - USE 2" STONE, OR RECLAIMED OR RECYCLED CONCRETE EQUIVALENT.
 - LENGTH - AS REQUIRED, BUT NOT LESS THAN 50 FEET

- THICKNESS - NOT LESS THAN 6".
 - WIDTH 16' MINIMUM, BUT NOT LESS THAN THE FULL WIDTH AT POINTS WHERE EGRESS OCCURS.
 - FILTER FABRIC (MIRAFI 500X OR EQUAL) - WILL BE PLACED OVER THE ENTIRE AREA PRIOR TO PLACING OF STONE.

- MAINTENANCE - THE ENTRANCE SHALL BE MAINTAINED IN A CONDITION WHICH WILL PREVENT TRACKING OR FLOWING OF SEDIMENT ONTO PUBLIC RIGHTS-OF-WAY. THIS MAY REQUIRE PERIODIC TOP DRESSING WITH ADDITIONAL STONE AS CONDITIONS DEMAND AND REPAIR AND/OR CLEAN OUT OF ANY MEASURES USED TO TRAP SEDIMENT. ALL SEDIMENT SPILLED, DROPPED, WASHED OR TRACKED ONTO PUBLIC RIGHTS-OF-WAY MUST BE REMOVED IMMEDIATELY BY THE CONTRACTOR.

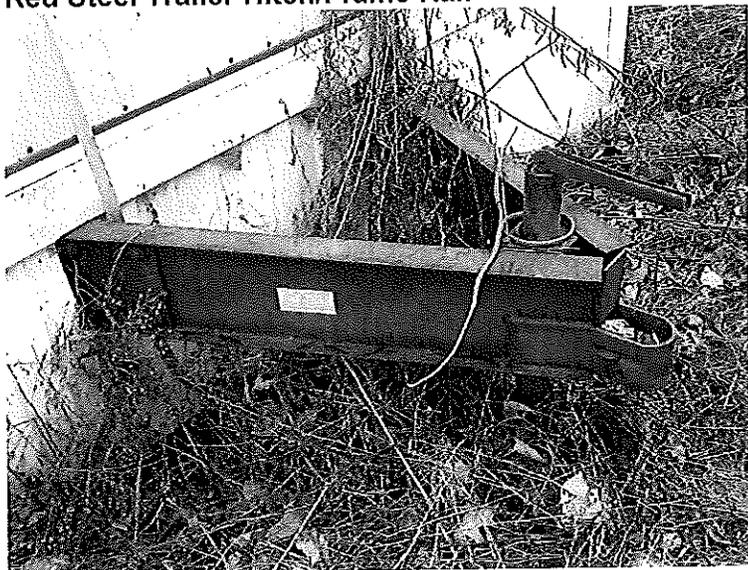
Red Steel Trailer Hitch/Frame Rail

- b. Page 003126-2, First Paragraph, Top of Page: Add the following Paragraph:
“D. Trailer Hitch Frame
1. Lead.”
- c. Page 003126-2, Article 1.02: Add the following to the end of the Paragraph:
“The above referenced ACM survey was completed in April 2013 and the results of the survey documented in Attachment 10 - Adelaide Environmental, Asbestos, lead based paint and PCB testing report-old office trailer, April 24, 2013.”

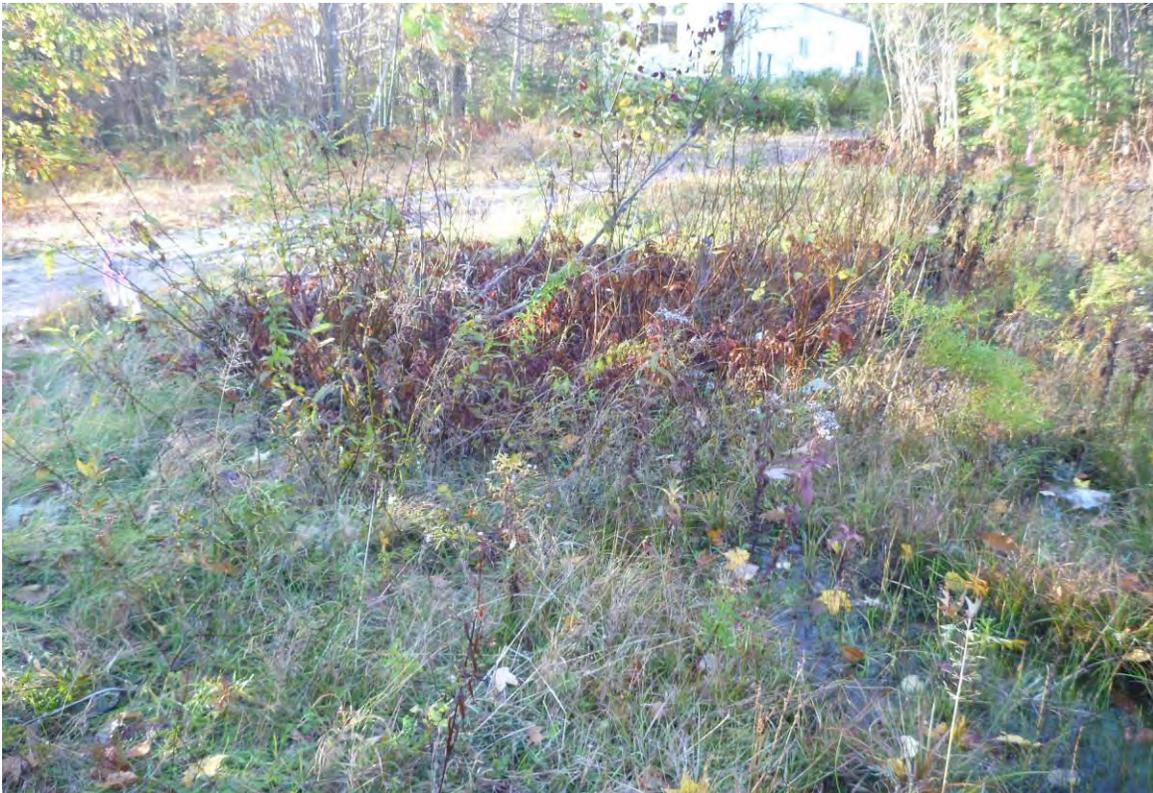
Photo 6. Looking southeast at the eastern portion of W3, which conveys water under gravel/sand road via culvert.
Date: October 16, 2012

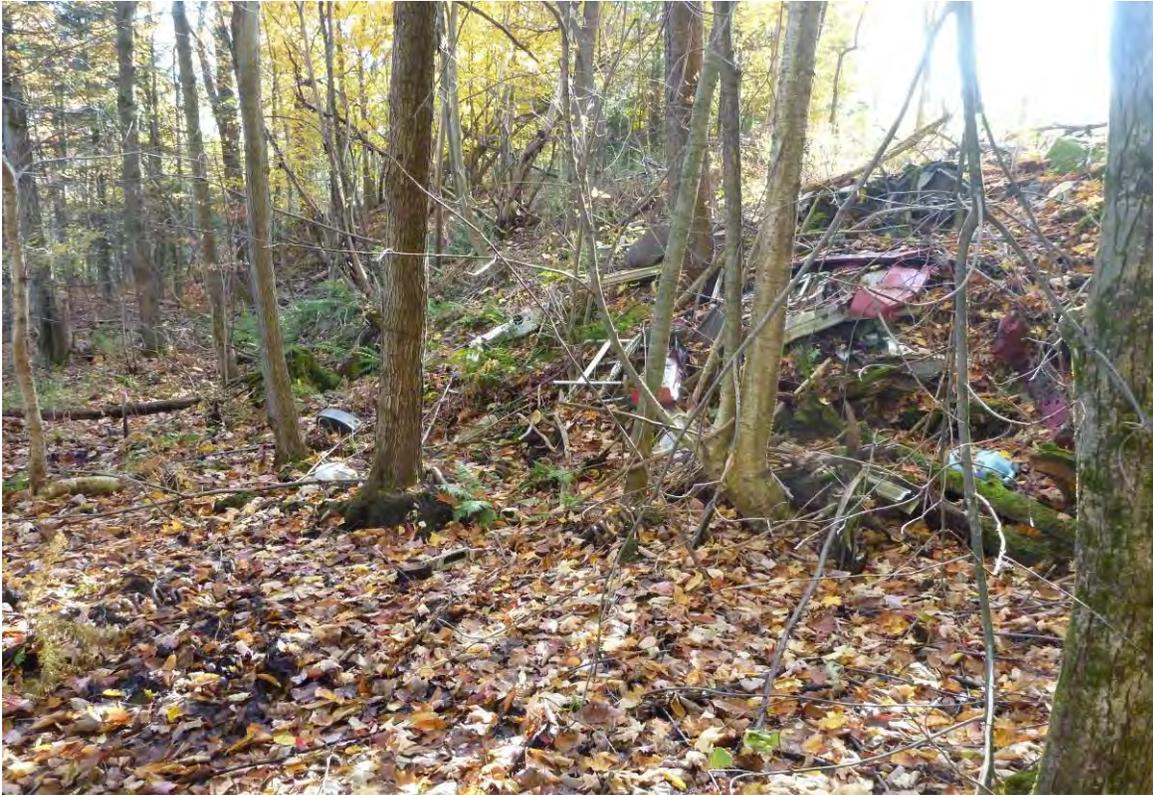
Photo 7. Looking southeast at berm and debris located north of the Skip Range.
Date: October 17, 2012

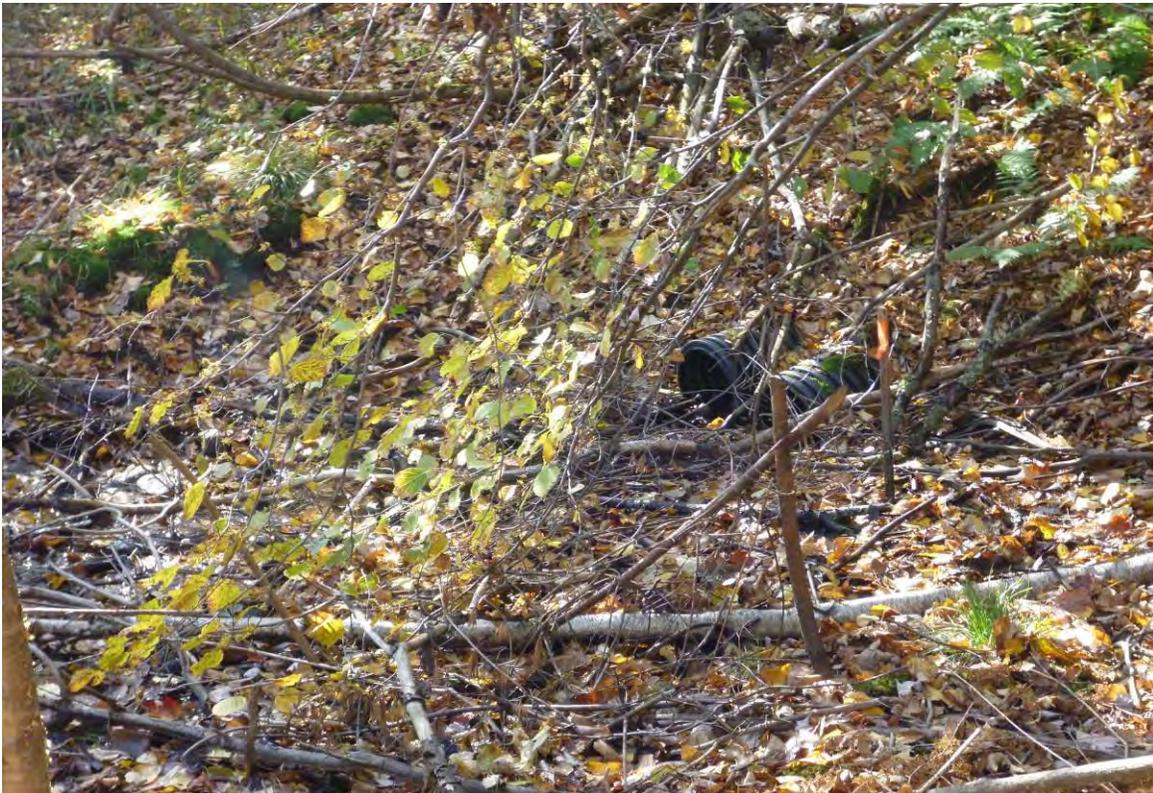
Photo 10. Looking south at double culvert at the mouth of S1 in the southern portion of W4.
Date: October 17, 2012

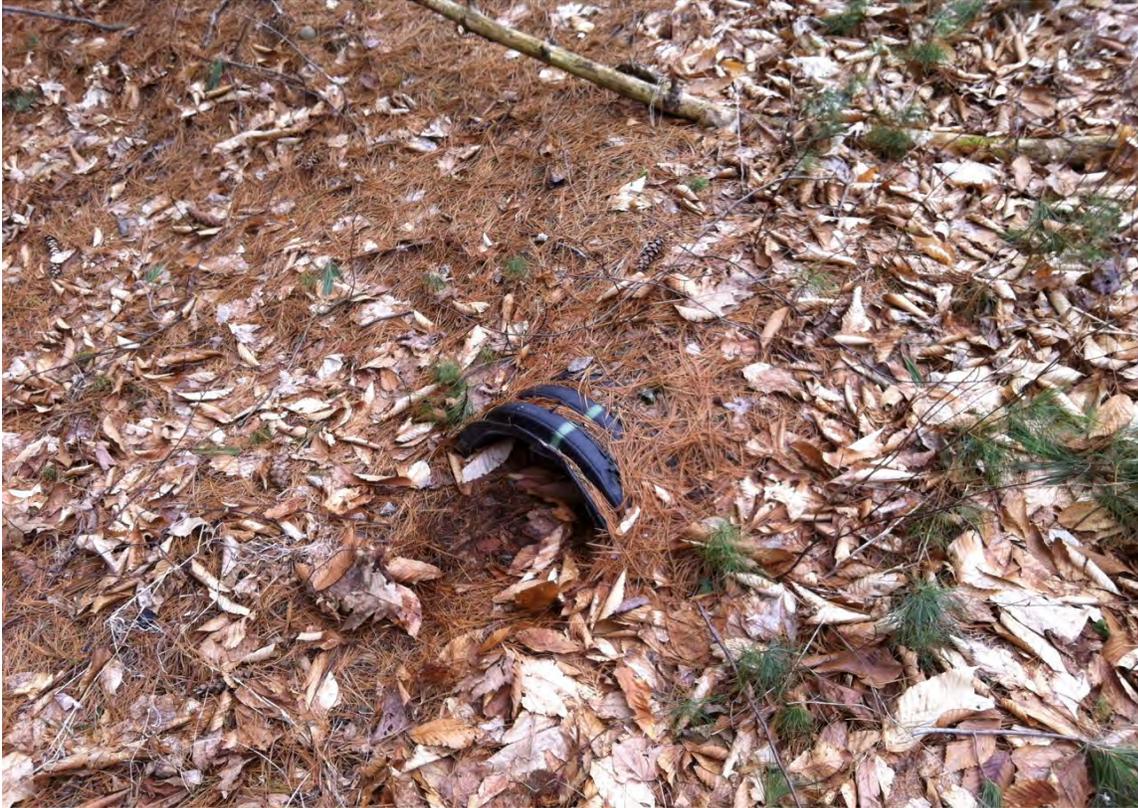
Photo 15. Looking at culvert discharge point on eastern side of Access Road.
Date: April 11, 2013
