ADDENDUM NO. 1 TO PROJECT NO. 44766

**CONSTRUCTION WORK
REPLACE ROOFS, BUILDINGS 80, 81, 82 & 90
INDUSTRY SECURE CENTER
101 RYDER HILL ROAD
RUSH, NY 14543**

LIMITED HAZARDOUS MATERIALS SURVEY

**INDUSTRY SECURE CENTER
BUILDING NOS. 80, 81, 82, AND 90
RUSH, NEW YORK
NYSOGS PROJECT NO. 44766**

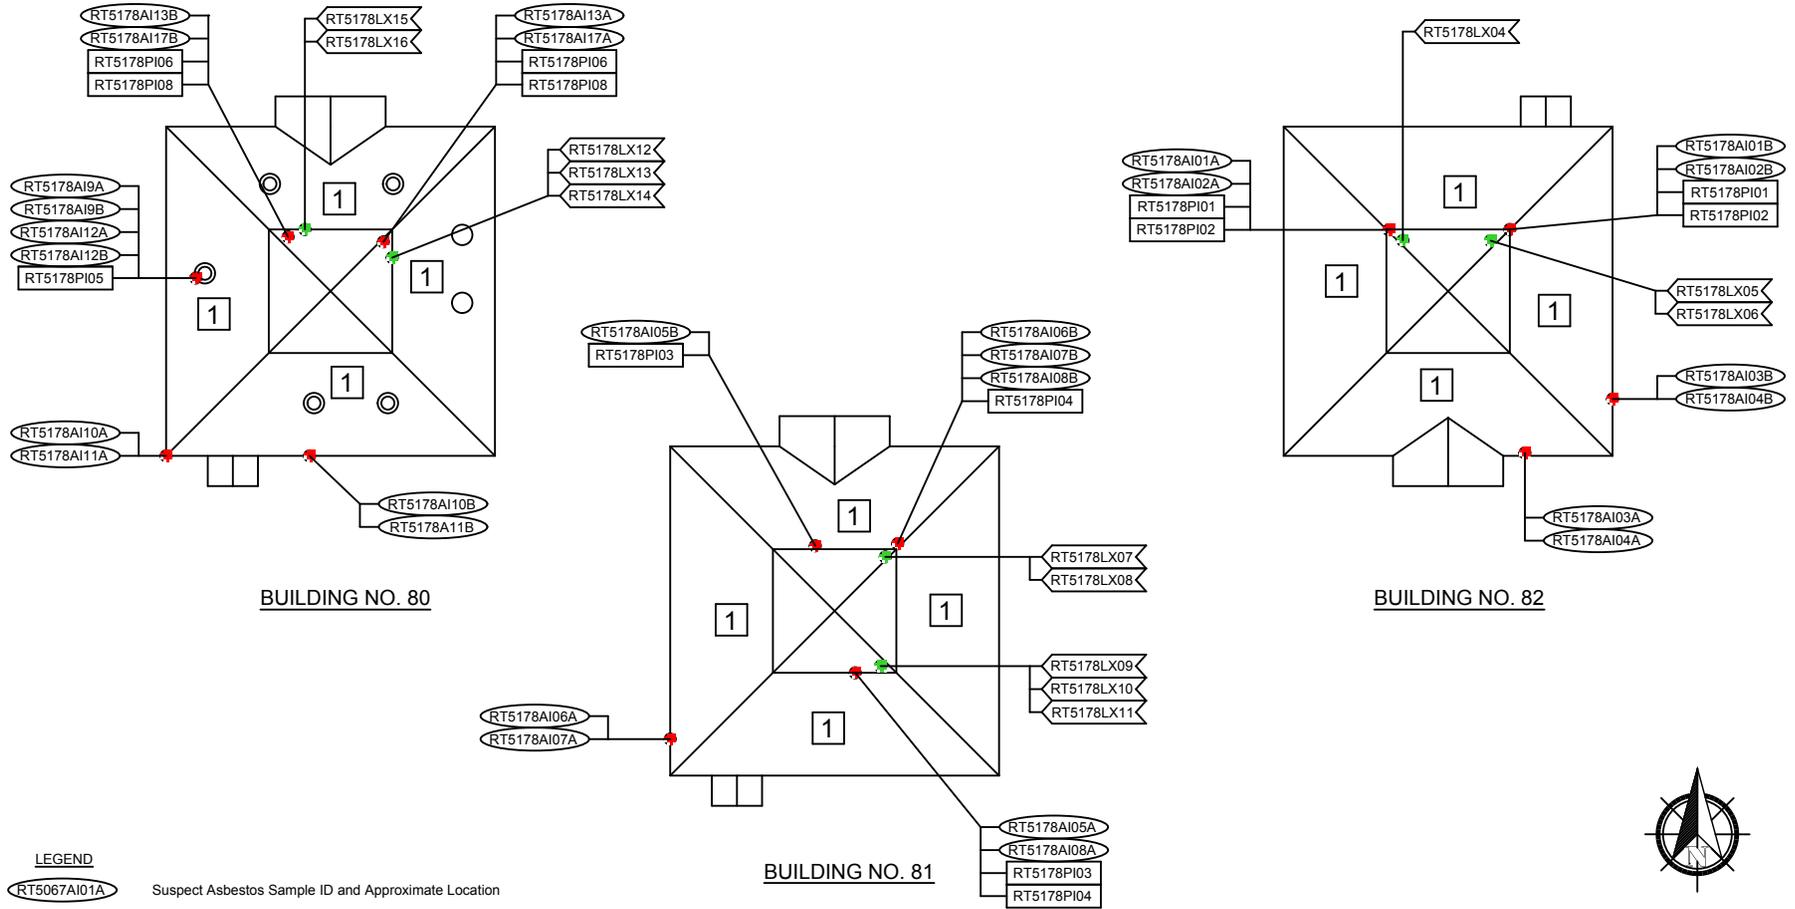
- LEGEND**
- RT5067AI01A Suspect Asbestos Sample ID and Approximate Location
 - RT5067PI01 Suspect PCB Sample ID and Approximate Location
 - RT5067LX01 Suspect XRF Lead Sample ID and Approximate Location
 - 1 Black/Gray, Penetration Tar

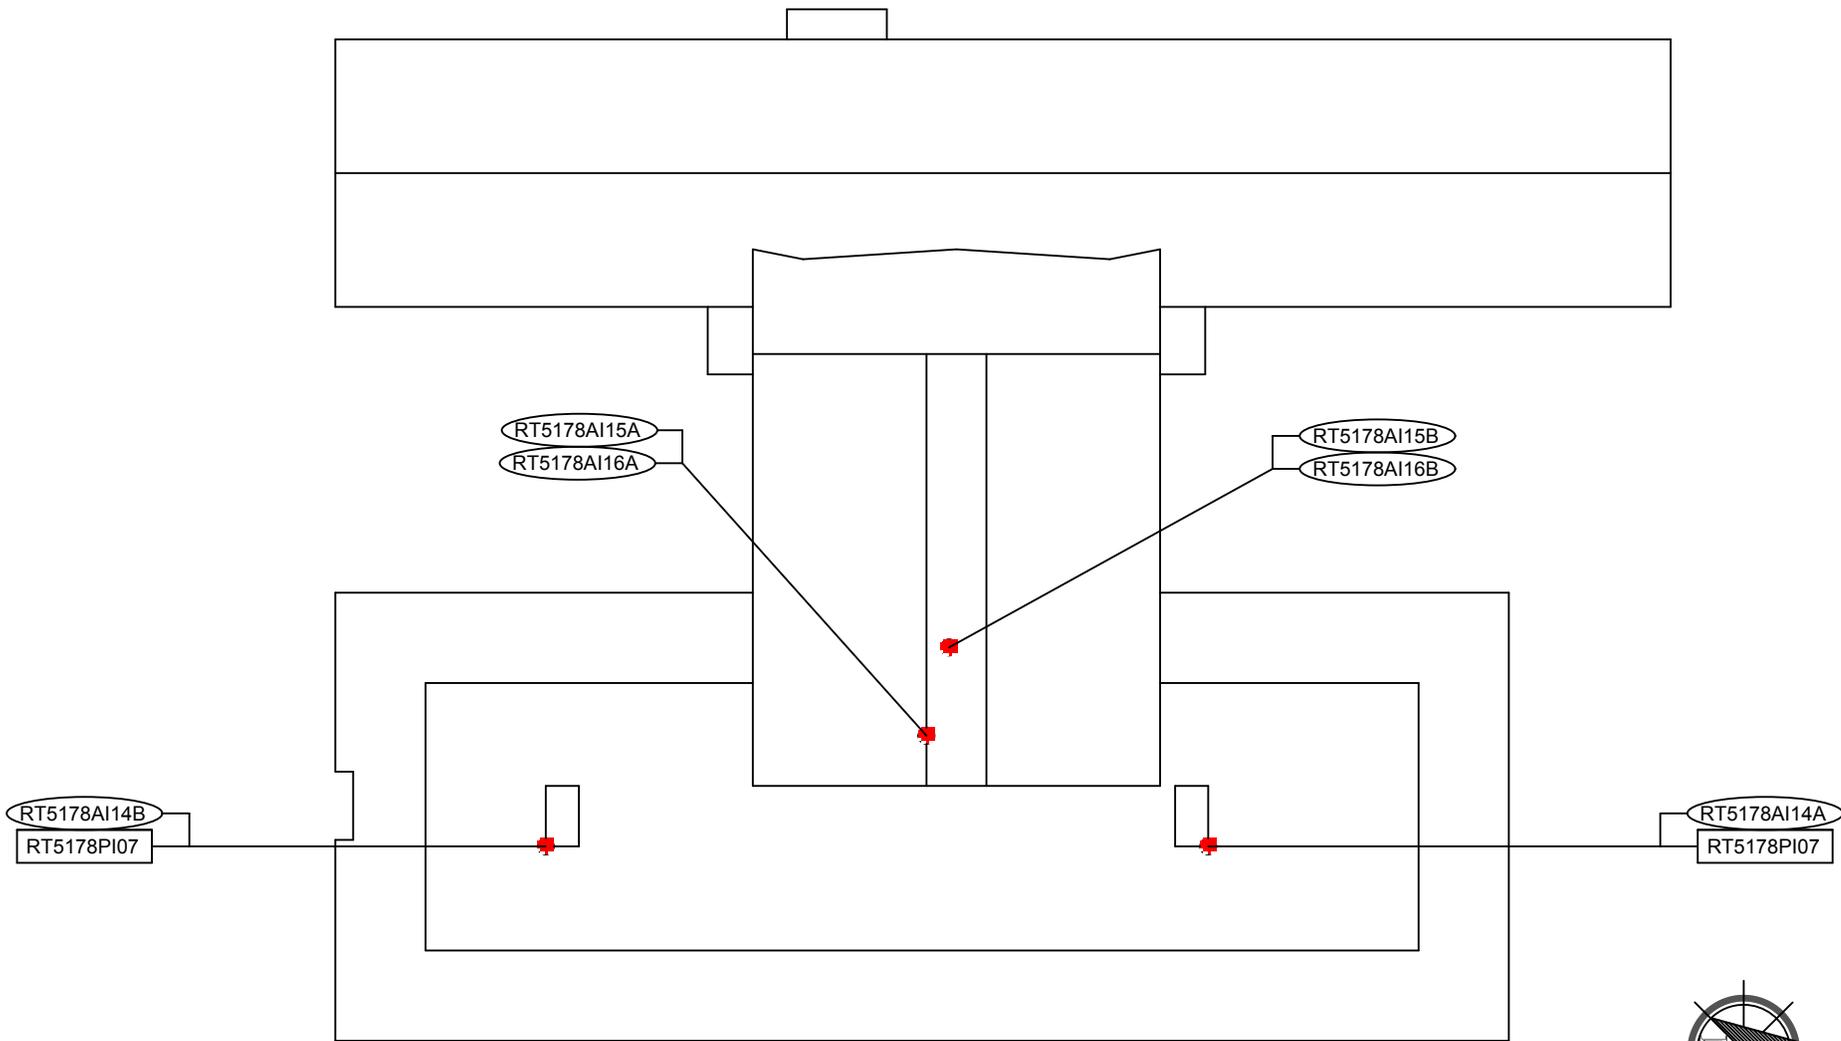
BUILDING NO. 90

- LEGEND**
- RT5067AI01A Suspect Asbestos Sample ID and Approximate Location
 - RT5067PI01 Suspect PCB Sample ID and Approximate Location
