ADDENDUM NO. 1 TO PROJECT NO. 43747

**CONSTRUCTION WORK
REPLACE ROOF
DOT REGION 5, CHAUTAUQUA COUNTY
154 CHAUTAUQUA ROAD
FREDONIA, NY 14063**

Reference: Replace Roof, DOT Region 5 – Chatauqua County
43747-C, DOT Fredonia - Core Cuts of Existing Roof

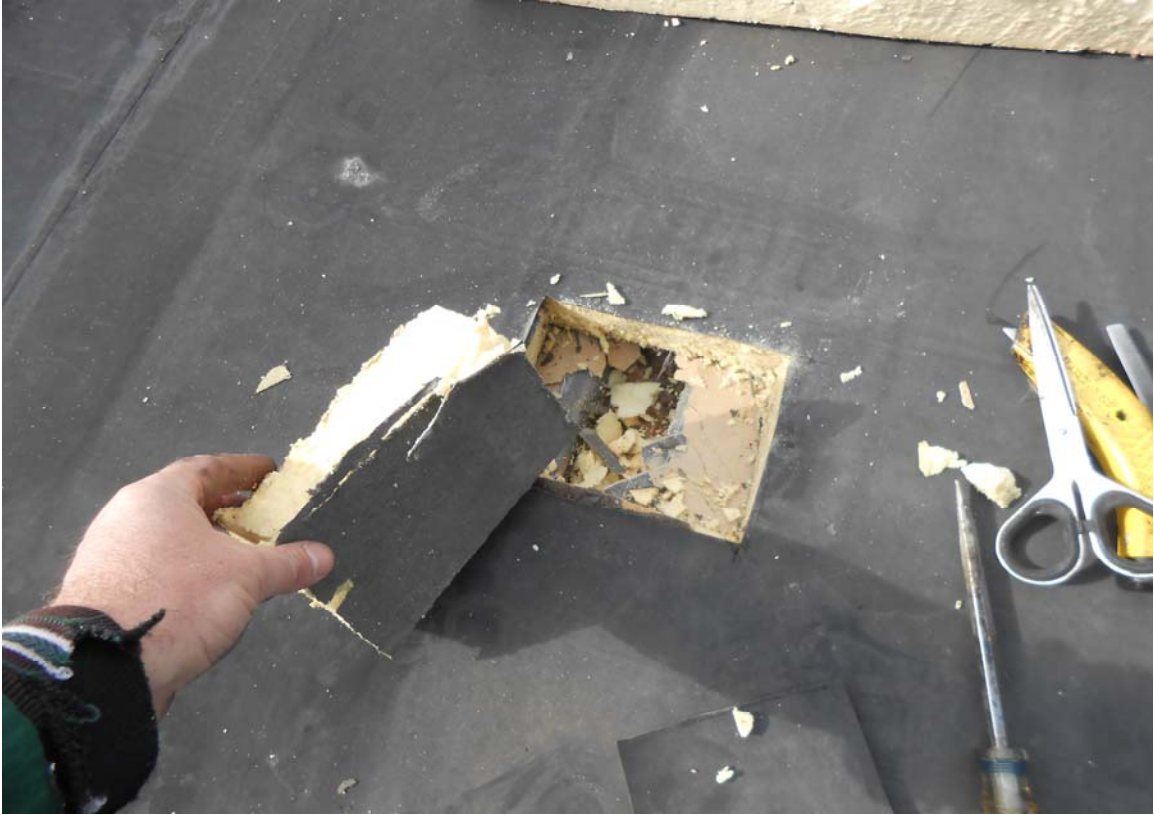
Picture No. 1 – Sample test cut of the lower roof level.

This past Tuesday morning (May 14, 2013), along with Tom Kozaczka from 56 Services, Inc., I took two core samples of the existing roof at the Fredonia DOT garage (please see Picture Nos. 1 and 2.) One sample was taken from the high roof and one sample was taken from the low roof. The results of both core cuts were identical:

- Fully adhered .060 EPDM membrane.
- 2” isocyanurate insulation.
- Reinforced kraft paper vapor barrier.
- Metal roof deck.

The reinforced kraft paper vapor barrier was tested for asbestos contamination and it came up negative.
